Development and validation of an automated NDE approach for testing welded joints in plastic pipes (TestPEP)

The project team, which involved 17 organizations from seven countries, is currently developing and validating inspection equipment and techniques for both butt fusion (BF) and electrofusion (EF) joints in polyethylene (PE) pipes.

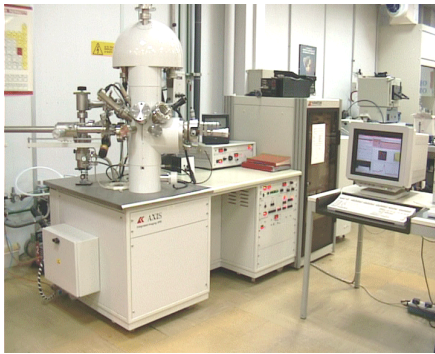
Picture of the AXIS-HS small spot XPS instrument by KRATOS Analytical Ltd. used in the project.

Consorzio Catania Ricerche through its Laboratorio Superfici ed Interfasi (SperLab) participated to the Project for the characterization of talc and sand contaminated welds by small spot X ray Photoelectron Spectroscopy (XPS). XPS, also known as Electron Spectroscopy for Chemical Analysis (ESCA) is a widely used technique to investigate the chemical composition of surfaces. XPS has been employed to quantify actual talc and sand contamination level in PE welds, after mechanical rupture. Mechanical test results on welds containing deliberate talc and sand contaminations have been compared with XPS results to develop flaws acceptance criteria. Flaws acceptance criteria concurred to the assembly and assessment of complete prototype system. TestPEP has been completed in April 2013 leading to the development of an automated non-destructive evaluation (NDE) of welded joints in plastics pipes.

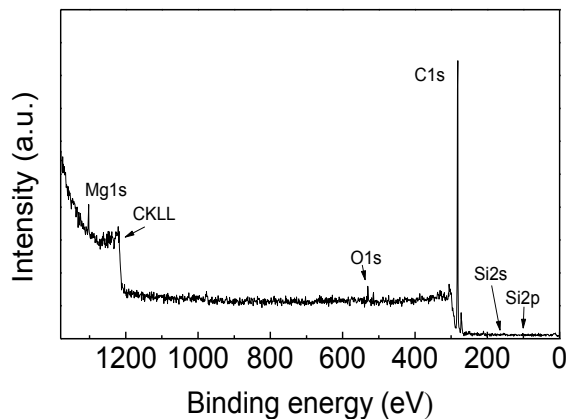
Typical XPS survey spectrum of a typical fractured weld having a low contamination level of talc, obtained by Al radiation.
